This document is the Asbestos Survey for 901-909 10th Ave.

RE: Asbestos Inspection – Weld County West Annex – North Building, 901 10th Avenue, Greeley;
MEC #2019.145

RE: Asbestos Inspection – Weld County West Annex – South Building, 903-909 10th Avenue, Greeley;
MEC #2019.145

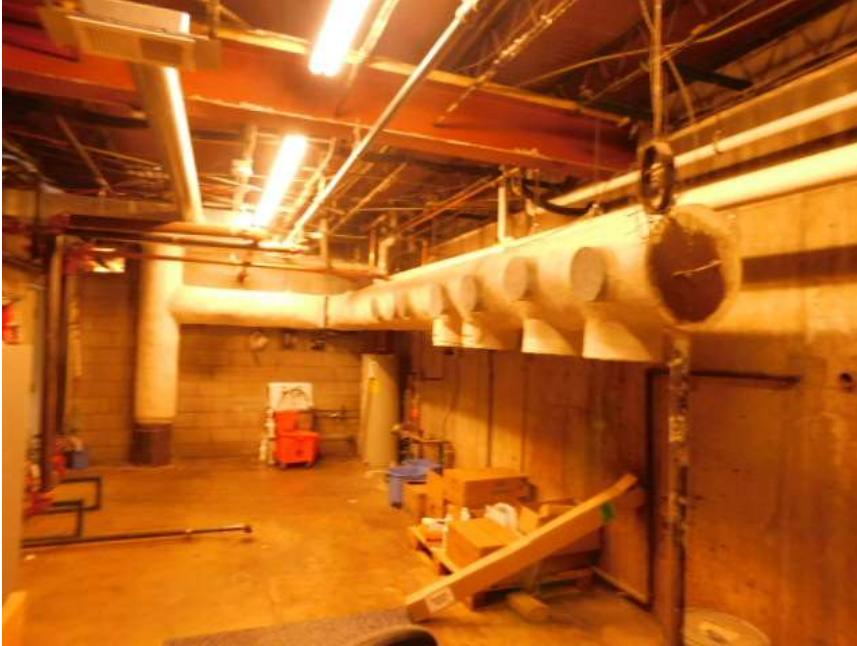
Asbestos was detected at concentrations greater than 1%, in three of the four samples of the TSI in the basement utility room. The piping/duct on which the TSI included was observed to be former inactive heat/cooling equipment, (18 inch in diameter, approx. 34 in total length, samples WAN-ASB16,17,18. This material is considered to have a Category 1 Hazard Potential.

View of basement utility room, with asbestos containing TSI coated heating system pipes. The piping appears to be inactive and disconnected.

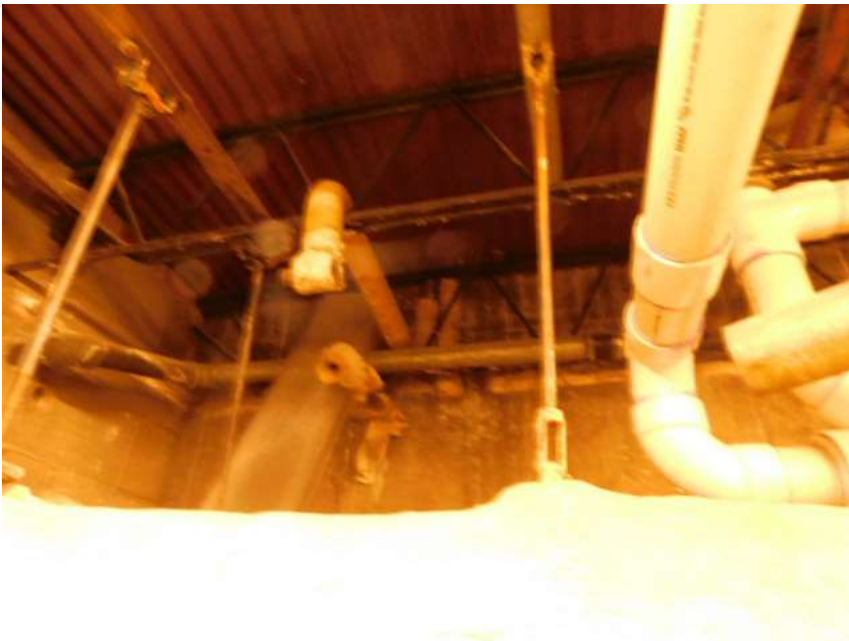
Also, MEC Inc. observed approximately 20 feet of insulated 1 inch piping suspended from the ceiling. Much of this piping is situated above the above TSI covering materials and was not readily accessible. One sample, (WAN-ASB19), of insulation and pipe mud extending from the wall has an asbestos concentration > 1%.

View of small diameter insulated water line piping above the large diameter TSI coated piping.

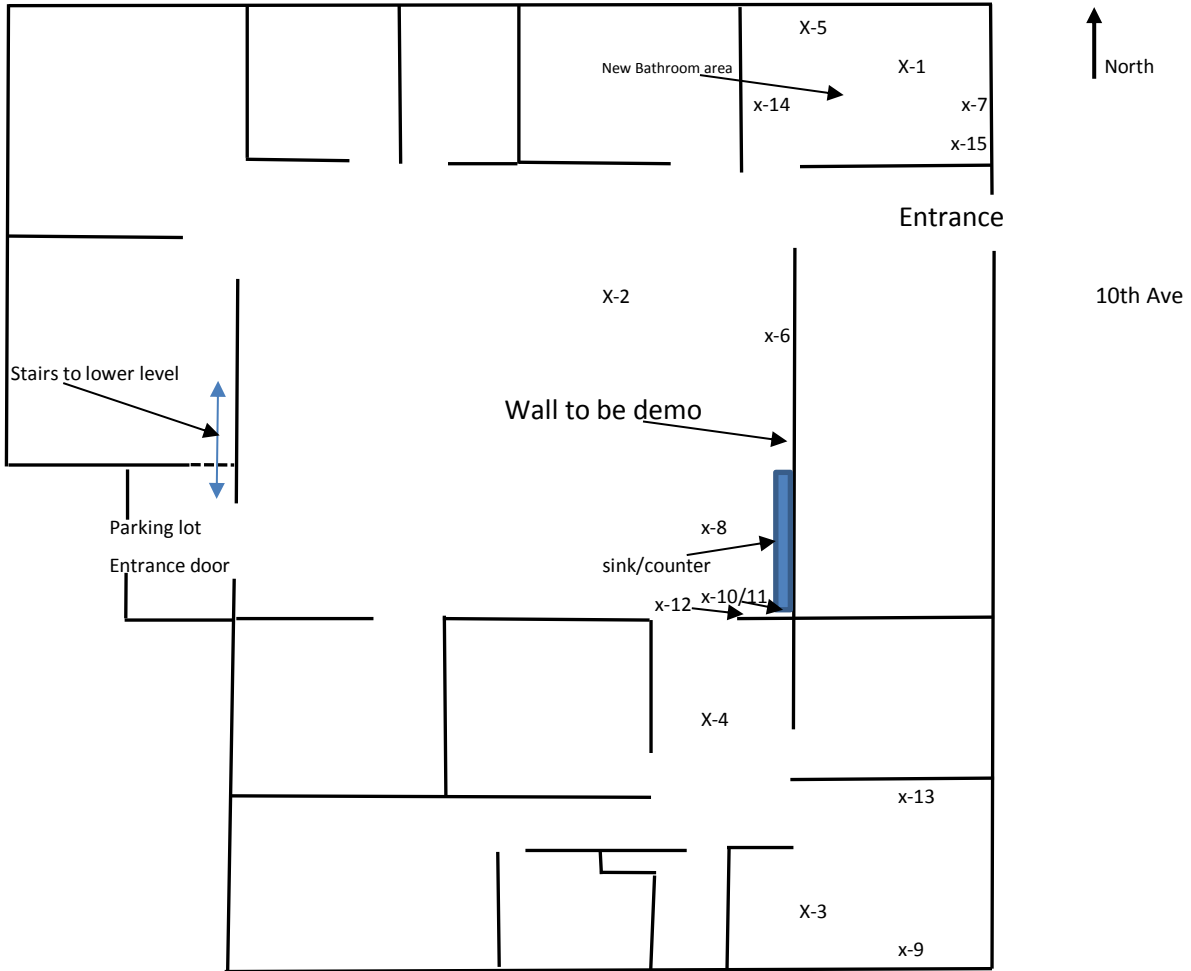
**Asbestos Sample Locations
 West Annex - North Bldg.
 901 10th Avenue
 Greeley, Weld County**

Samples ASB-16-19 in lower level, south end equipment room, inactive HVAC TSI ducts

Sample ASB-20 in lower level, east side hallway approximately below main level sink location, suspended acoustic panel

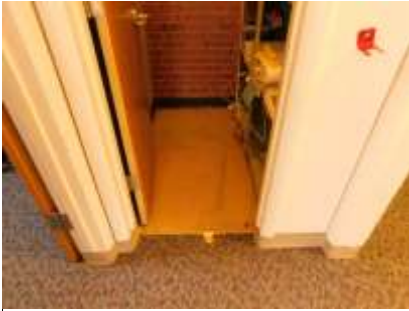
A limited amount 6 SF of asbestos containing white floor tiles were identified in the hallway south closet. These materials were observed to be in good condition. This materials is considered to be non-friable.

White floor tile, 6 SF, in south closet in hallway.

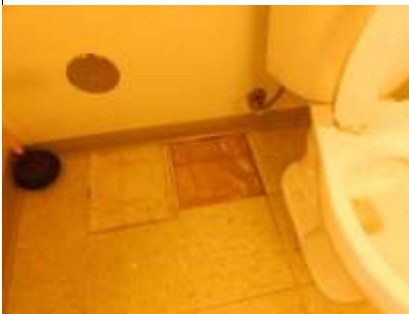
Asbestos containing floor tile mastic (cream/yellow color), approximately 52 SF was found in the restroom areas. Sampling of floor tile and mastic observed in the building (exposed and below the carpet) did not identify additional asbestos containing mastic. This materials is considered to be non-friable.

Mastic below the lower brown floor tile layer in the mens and women restroom contained asbestos at > 1%.

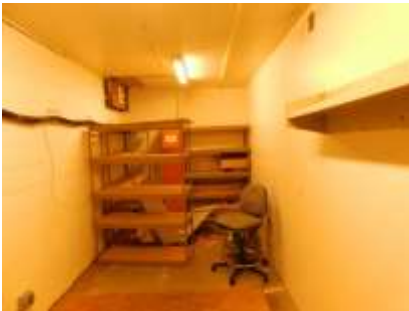
As summarized in the sampling table the smooth surface wallboard assembly (WBA) drywall materials in the west side of the building had asbestos containing compound materials, > 1%. Overall, the composite calculations for these samples ranged from <1% to >1%. The lab results are summarized in Table 1. The majority of the WBA was observed to be in good condition, with localized damage and water damage. This materials is considered to be friable.

View of wallboard material in storeroom with asbestos wallboard assembly compound > 1%.

Asbestos was also detected in the joint compound of the smooth surface wall and ceiling drywall materials in the hallway, storage room, and restrooms. The laboratory composite calculation results for these asbestos containing materials were < 1 % and > 1% of the WBA materials. Based on these wall board materials are considered to be asbestos containing materials (ACMs). It is recommended that these materials be removed in an appropriate manner
