**SUBJECT: Asbestos Survey and Bulk Sampling for Building Demolition
1020 9th Street, Greeley, Colorado**

ASBESTOS SURVEY AND BULK SAMPLING REPORT

FOR BUILDING DEMOLITION OF

1020 9th Street, Greeley, Colorado

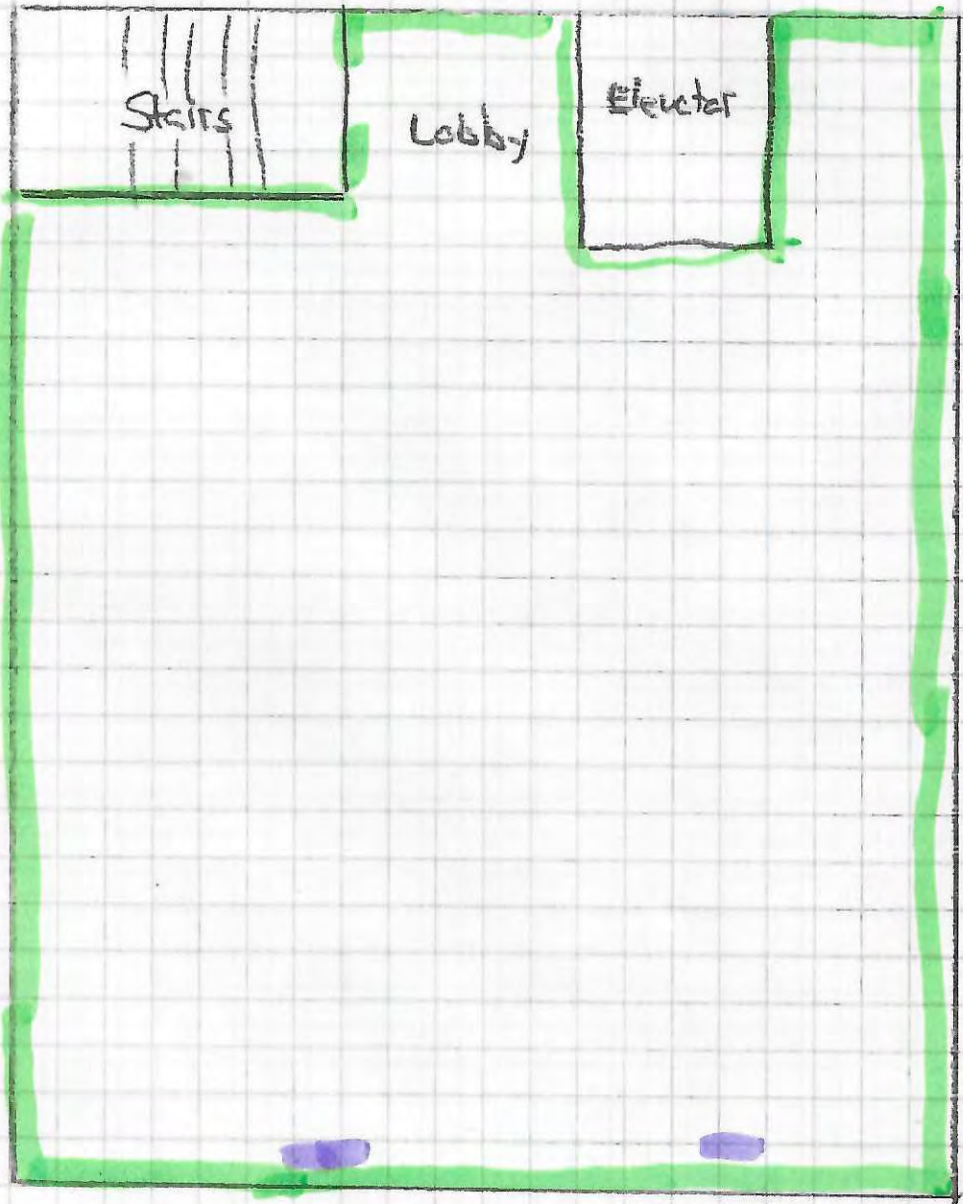
1020 9th St, Greeley
3rd Fl N

-   Texture
-   Adhesive
